May 21, 2024 NewFields Project 475.0022.003

FIRST QUANTUM MINERALS COBRE PANAMA Torres de Las Américas Torre A, Piso 21 Iguana Mall Penonomé Donoso, Colón

RE: INITIAL FEEDBACK FOLLOWING SITE INSPECTION OF TAILINGS MANAGEMENT FACILITY AT COBRE PANAMA

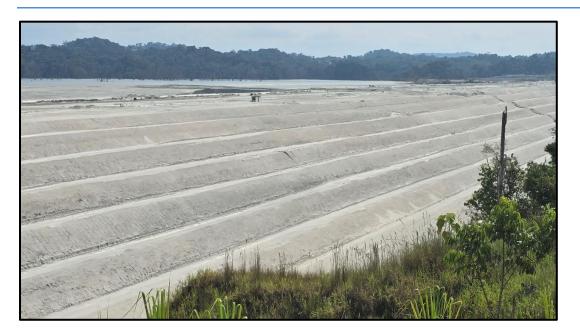
Figure 1: Western section of North wall at Cobre Panama TMF

The Cobre Panama TMF is located in an area of high rainfall intensity. As such the TMF is subject to significant erosion and as a result constant management of erosion and stormwater is required on the facility's outer slopes. As shown in Figure 1, the erosion currently on the outer embankment (wall) is considered negligeable due to ongoing maintenance and management.

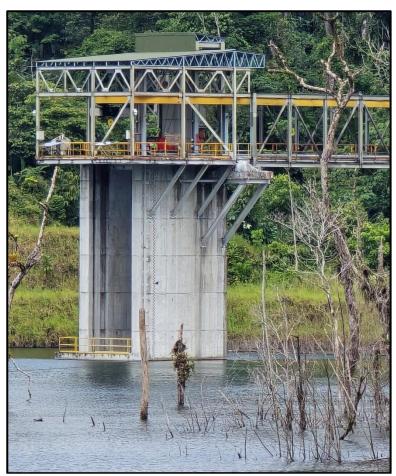
Figure 2: Spillway Tower at the Cobre Panama TMF

Another aspect that needs to be managed carefully in such a high rainfall environment is the size and shape of the supernatant pond on the facility. The design of the TMF includes a Spillway Tower as shown in Figure 2. This tower has been designed with the capacity to discharge stormwater and prevent excessive pond size with minimal operational oversight from the TMF operator.

- The location of the Spillway Tower in proximity to the North Wall is not ideal and relocation of this location to a position deeper into the TMF is recommended.
- Closure designs for the facility need to be advanced.
- Ongoing maintenance and management of this facility, as is presently in place, is essential to the facilities stability and minimizing environmental impacts and must be maintained.
- Filter compatibility of the cyclone sands with the 'Zone 3' filter material needs to be evaluated as it seems that some seepage water is not flowing into the filter.
